## LANDSLIDES AND RELATED FEATURES

OF THE HOOVERSVILLE, PA. QUADRANGLE

by  
John S. Pomeroy

OPEN FILE MAP 79-1314 (B-9)

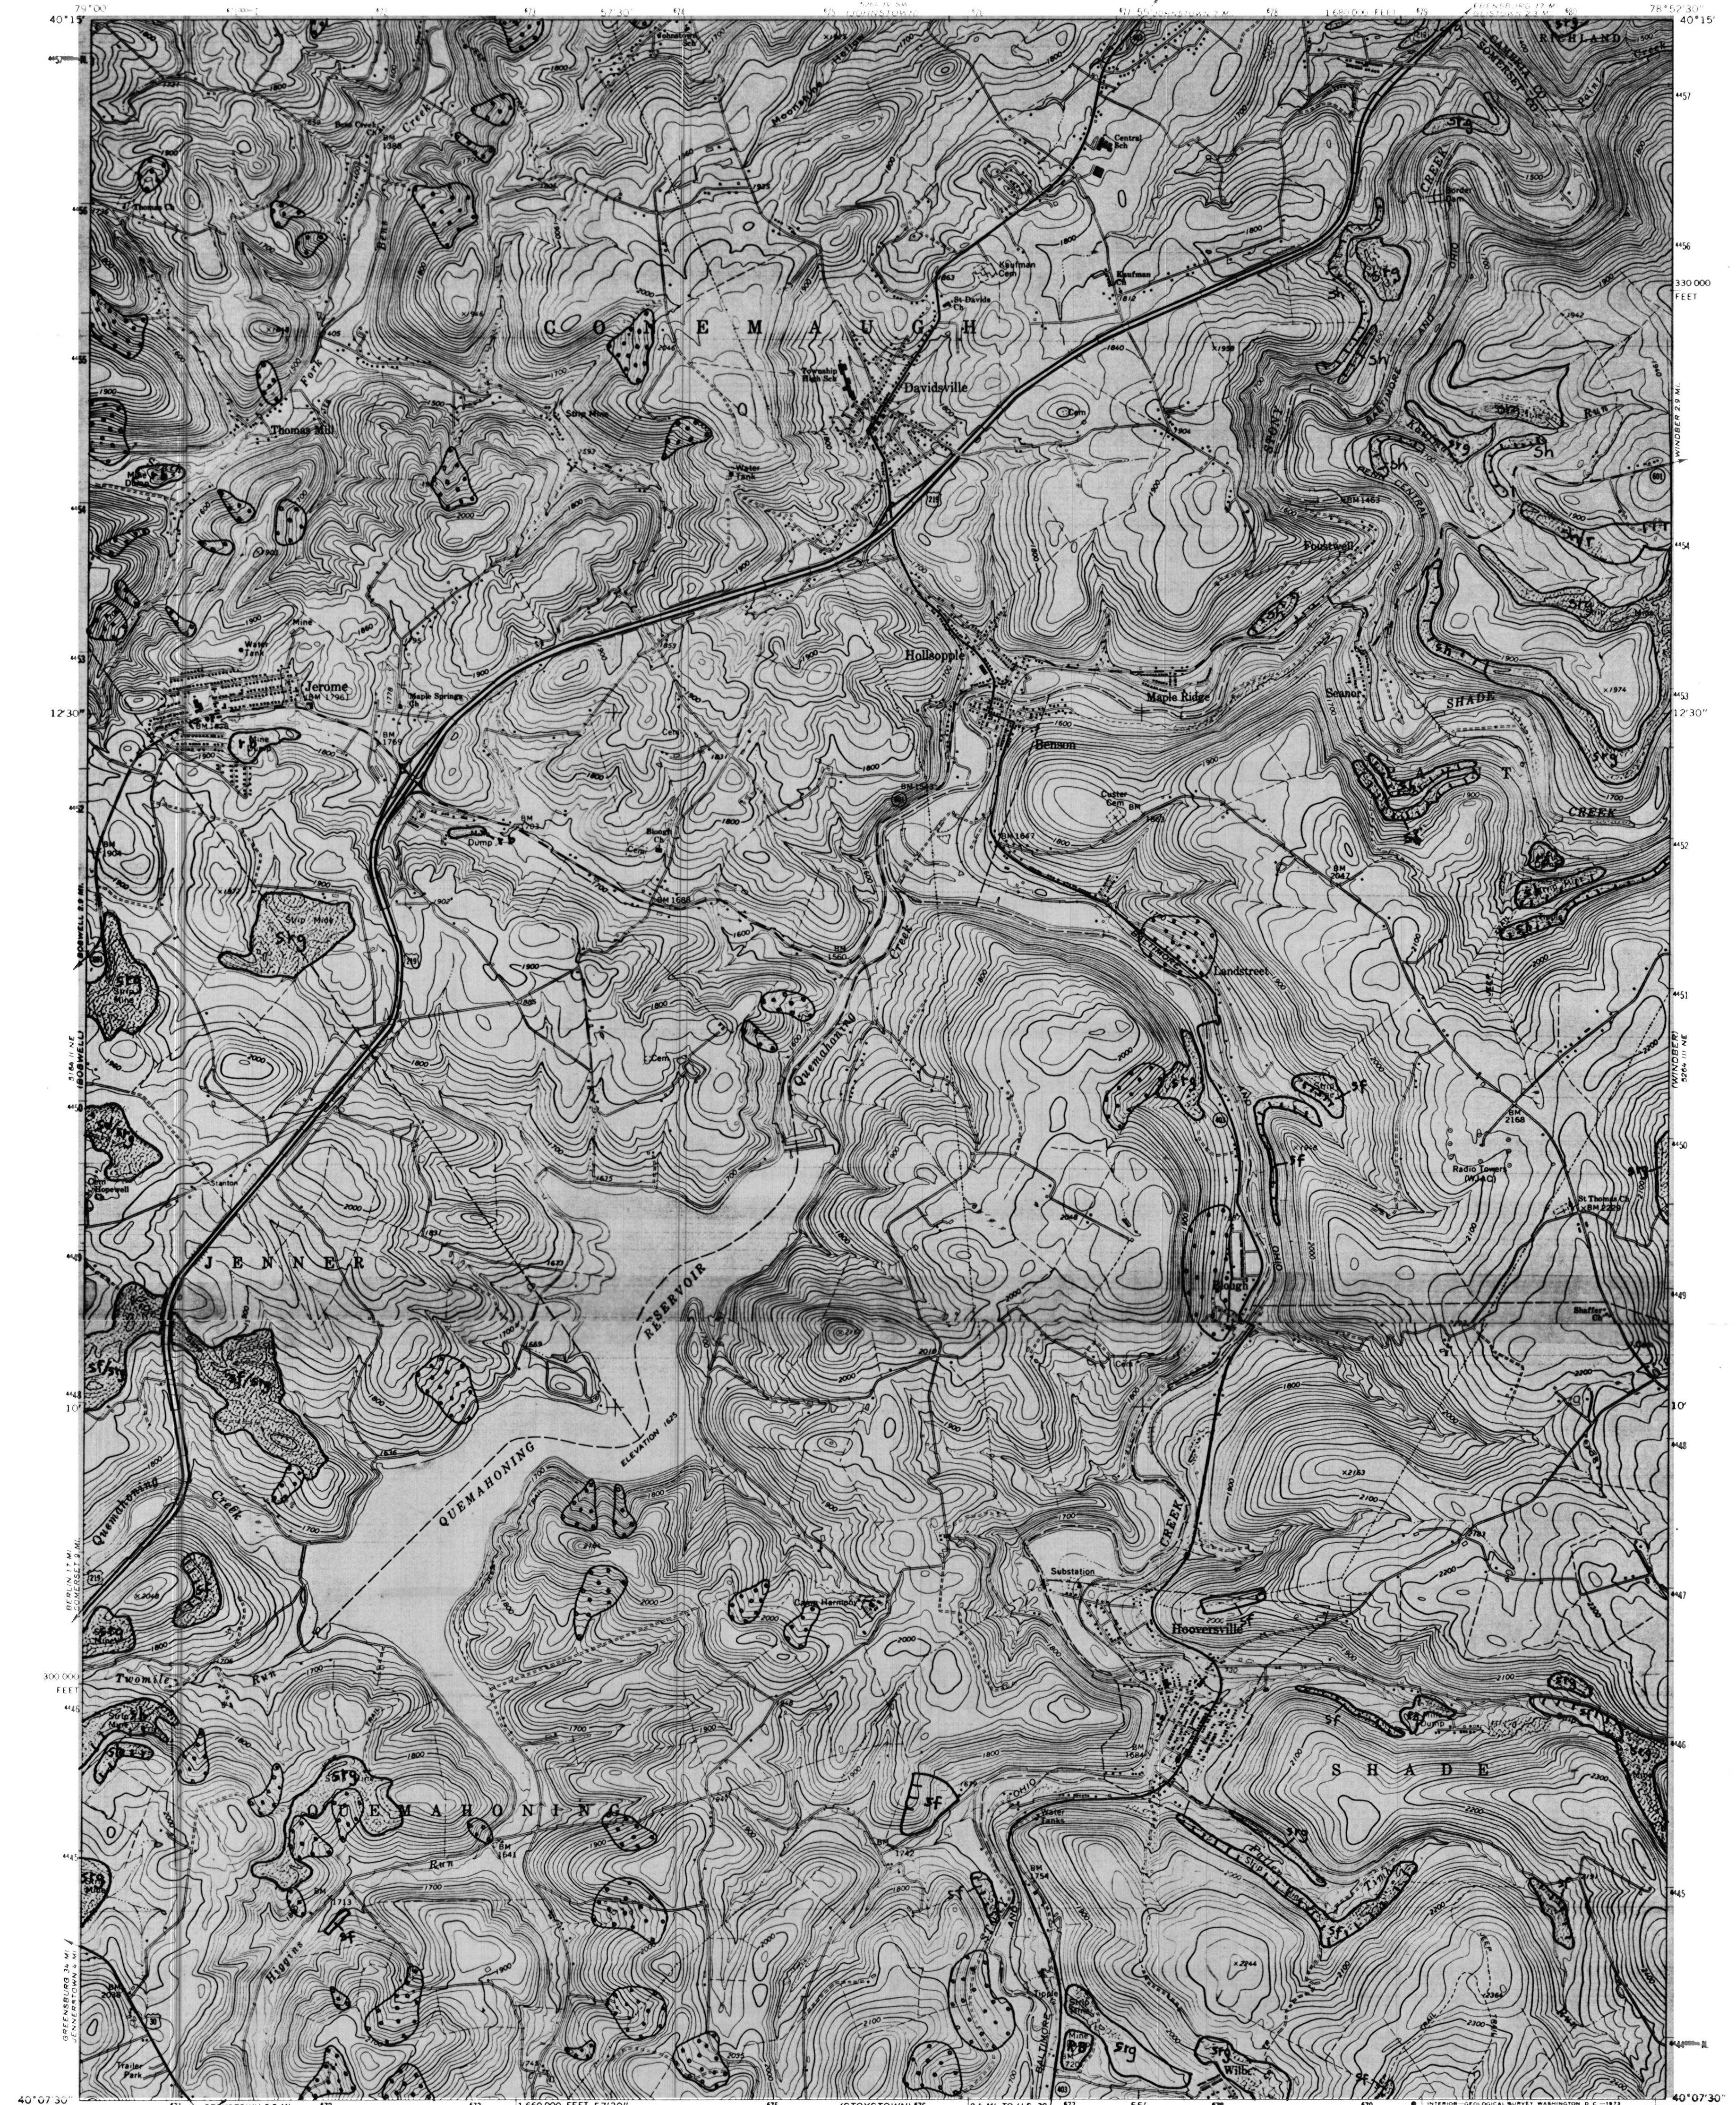
**ACTIVE OR RECENTLY ACTIVE LANDSLIDE**  
Complex landslide composed of earthflow, debris  
slide, earth and rock slump. Identified from  
historical records, and from scars, debris and  
other field evidence. Ground extremely unstable;  
sliding accelerated by excavation, loading and  
changes in drainage conditions. May include  
areas with several active slides too small to  
be shown separately. Questioned where doubtful.

**OLD LANDSLIDE**  
Area of extensive hummocky ground caused by  
earthflow and earth and rock slump. Lacks  
clear evidence of active sliding. Relatively  
stable in natural, undisturbed state,  
generally not affected by small structures properly  
sited in areas away from the edge of the toe;  
can be reactivated by extensive, rapid exca-  
vation, loading, and changes in ground water and  
surface water conditions. Area of old landslide  
probably includes recent ones not identified  
from field evidence or otherwise documented.  
Upslope boundary of landslide generally defined  
by modified scarp, but downslope (toe) may be  
gradational and not well defined. Questioned  
where doubtful.

**COMBINATION LANDSLIDE**  
Area of recent and old slides in which  
individual slides are not identified.

**COLLUVIAL SLOPE**  
Valley wall along major streams with slope as  
steep as 40° (85%); stony, clayey silt soil up  
to 50 ft. (15 m) thick; commonly buttressed by  
a terrace or bench at the toe of the slope; very  
susceptible to sliding by cutting of toe area,  
removal of terrace or bench, and overloading;  
slide commonly activated without apparent cause.

**SCREE**  
Residual accumulations of coarse rock material  
lying on quartzite slopes of the Valley and  
Ridge province. Generally stable except where  
subjected to extreme rainfall.

**COLLUVIAL SLOPES WITH LANDSLIDES**  
Landslides too small or obscure to map  
individually.

**AREAS SUSCEPTIBLE TO DEBRIS FLOWS AND DEBRIS  
AVALANCHES**  
Primarily shallow, narrow ravines and chutes with  
accumulation of stony colluvium generally 10 ft.  
(3 m) or less in thickness; susceptible to rapid  
movement during intense rainfall. Most ravines  
and chutes designated show evidence of former  
debris flows and avalanches. Symbol & design-  
ates historical debris flow or debris avalanche.

**AREAS SUSCEPTIBLE TO ROCKFALL**  
Steep, locally vertical, natural and man-made  
slopes and cliffs, 15 ft. (4.5 m) or more high;  
formed dominantly of sandstone, limestone, sandy  
shale, mudstone and claystone. Interbedded mud-  
stone, claystone and shale weather rapidly leaving  
sandstone and limestone rock faces unsupported.

**SOIL AND ROCK SUSCEPTIBLE TO LANDSLIDING**  
Soil and rock similar to that involved in land-  
slides elsewhere in map area; primarily areas  
underlain by claystone, mudstone and shale  
associated with other rock types. Rock weathers  
rapidly on exposure forming clayey soil highly  
susceptible to sliding. Includes coves (U-shaped,  
shallow valleys) containing thick layers of clayey  
soil that are very susceptible to sliding where  
excavation breaks continuity of slope and where  
overloaded by artificial fill.

**AREAS LEAST PRONE TO LANDSLIDES**  
Map areas in which no patterns or symbols are shown;  
primarily valley floors, ridge tops and broad  
benches; modification by excavation and fill may  
lead to local landslides.  
Includes slopes where landslides are sparse.  
The first five digits of the open file number designate the  
specific 1:250,000 scale map sheet of which this quadrangle  
is a part. The last two digits designate the position of the  
quadrangle in a subdivision of the 1:250,000 scale map based  
on rows and tiers shown in the diagram to the right. The  
location of this quadrangle is shown by the black square.
